Insight Inspections, LLC
Home Inspection Report

5534 Prairie Hawk Dr, Bel Aire, KS 67220
Inspection prepared for: Gretchen Stroh
Date of Inspection: 5/21/2018

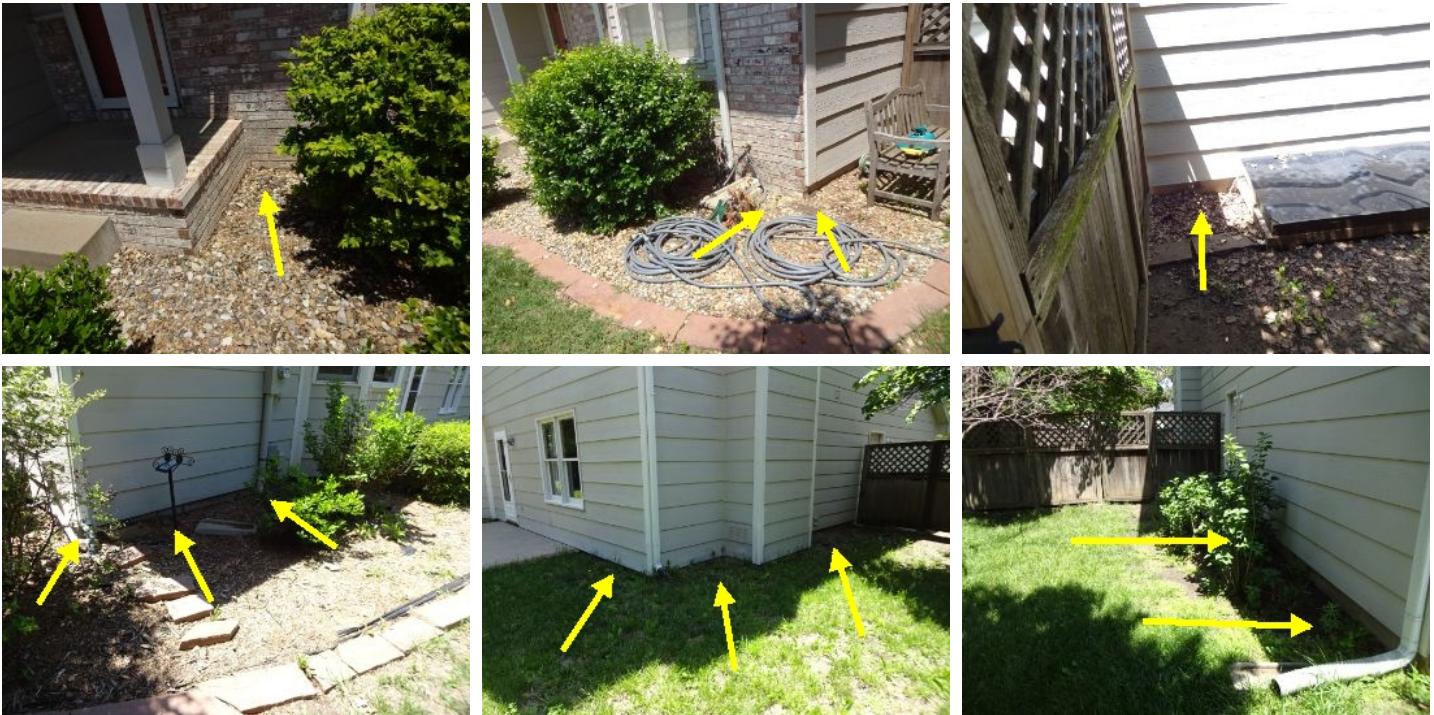
3. Grading & Surface Drainage

- NOTE: Lot grading and drainage have a significant impact on the building simply because of the direct and indirect damage that moisture can have on the foundation. It is very important that surface runoff water be adequately diverted away from the home. Furthermore, items such as leakage in downspout/gutter systems are very difficult to detect during dry weather. Inspection of foundation performance and water handling systems, therefore, is limited to visible conditions and evidence of past problems.
- **Negative slopes/flat areas/holes were observed on the front, right, back, and left side of the home. I recommend adding dirt to correct these areas to promote positive drainage away from the foundation.**

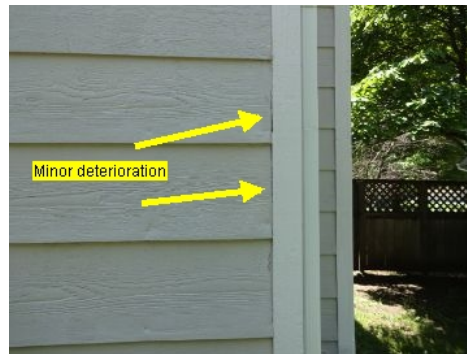
1. Exterior Walls

- The front of the home was covered in brick veneer and masonite siding. The rest was covered in masonite siding.
- **Minor deterioration was observed on the siding on the back of the home.**

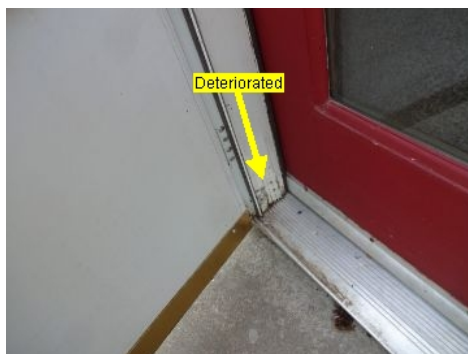
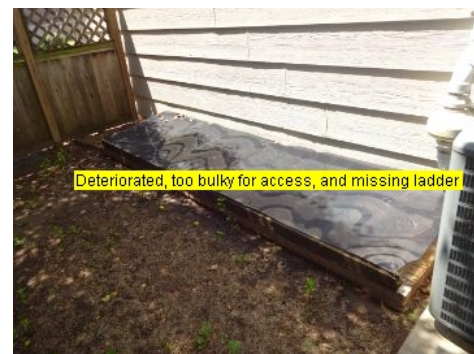
2. Windows & Doors

- **The door jamb on the back door was deteriorated at the bottom.**
- **The window well cover was deteriorated, too heavy/bulky for egress, and missing a ladder for egress.**

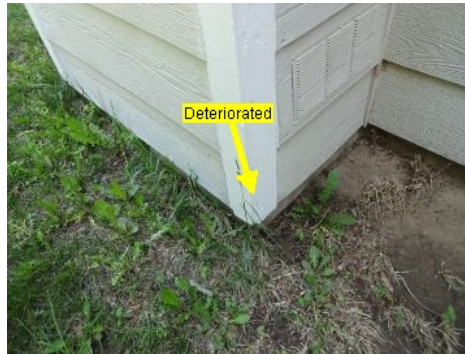
3. Soffits, Fascia & Trim

- **An area of trim was deteriorated on the left side of the home.**

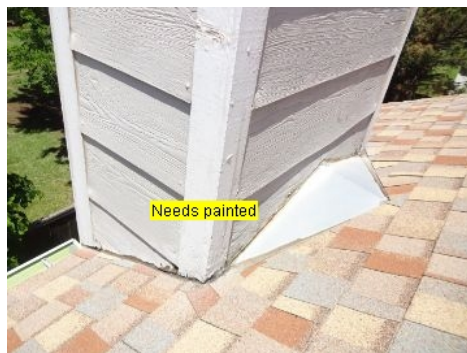
4. Chimney Observations

- Chimney had some exposed siding and needs painted to prevent deterioration.

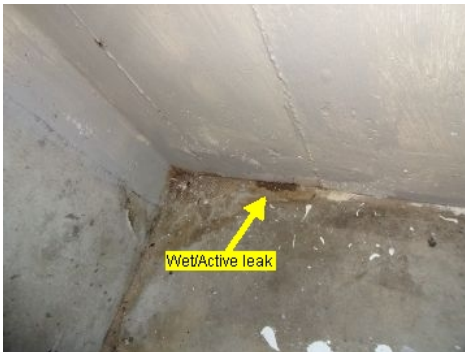
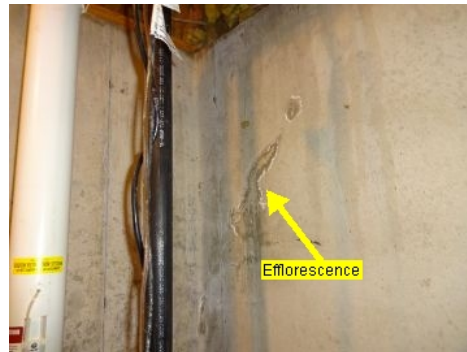
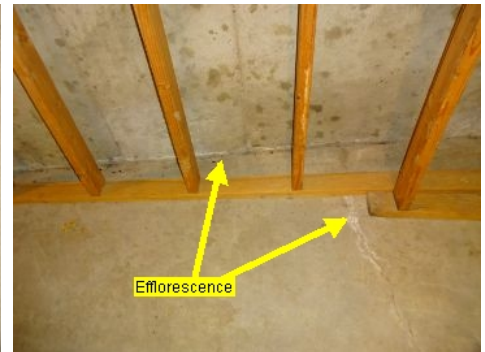
1. Ceilings & Walls

• **An active water leak was observed in the lower level. Efflorescence was also observed in the lower level. I recommend correcting all exterior drainage.**

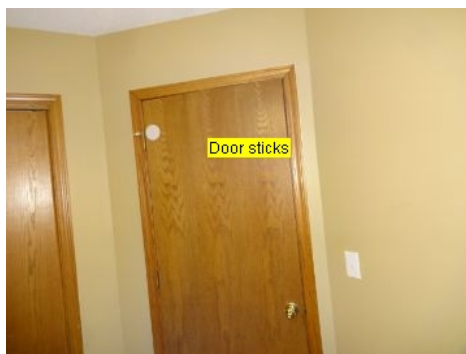
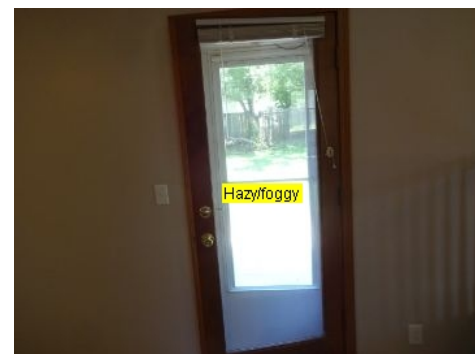
3. Doors

• Upper level bedroom door was sticking and needs adjusted.

• **Foggy/Haziness was present in the back door, indicating a broken gas seal.**

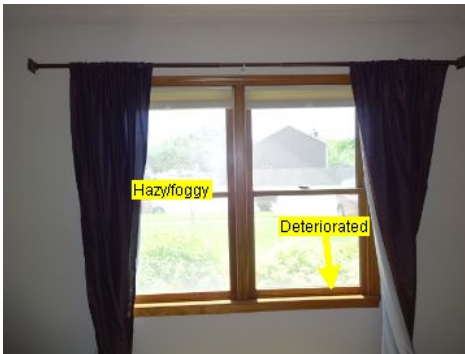
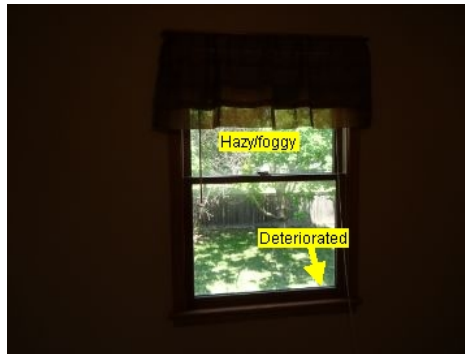
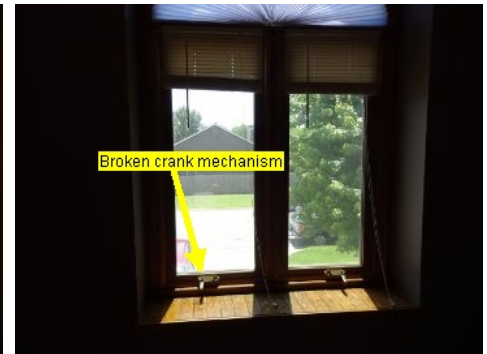
4. Windows

- **Foggy/Haziness was present in the living room and upper level bedroom window, indicating a broken gas seal.**
- **A couple of windows were deteriorated on the bottom.**
- **Master bedroom window had a broken crank mechanism. It would open, but it had to be pushed closed.**

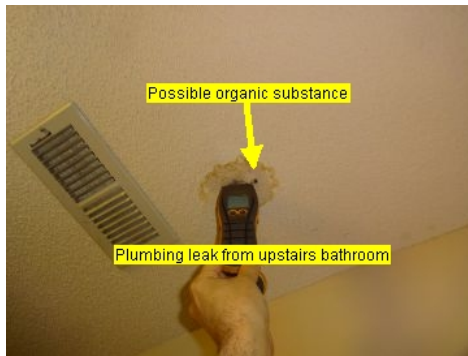
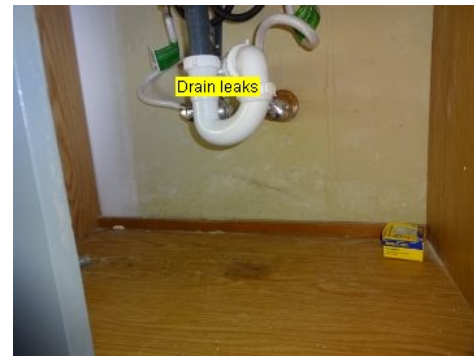
4. Drain/Waste/Vent (DWV)

- NOTE: The inspector attempts to evaluate drain pipes by flushing every drain that has an active fixture while observing its draw and watching for blockages or slow drains, but this is not a conclusive test and only a video-scan of the lines would confirm it's actual condition.
- **One of the bathrooms in the upper level has a leak. The ceiling was wet in the laundry room. A possible organic substance was also observed on the ceiling.**
- **Main level 1/2 bath drain was leaking.**

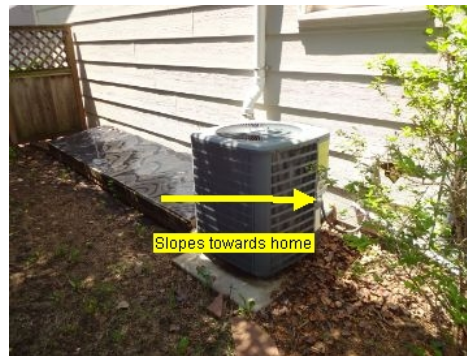
3. Description of Cooling System

- The home had a split system central air conditioner installed on the right side of the home.
- The air conditioner was manufactured by Goodman in 2009.
- **The AC unit was sloping towards the home. It should slope away to direct water away from the foundation.**

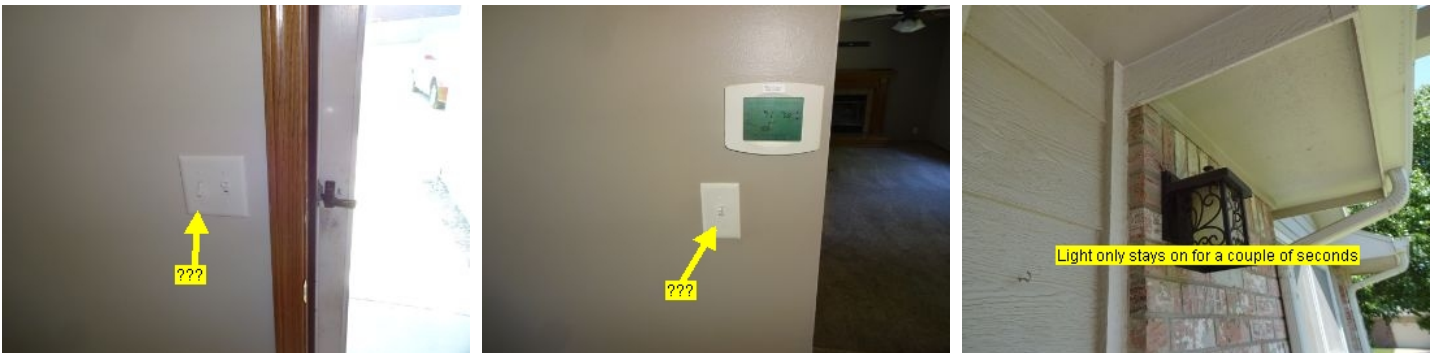
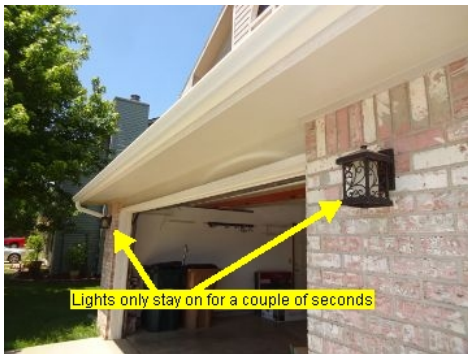
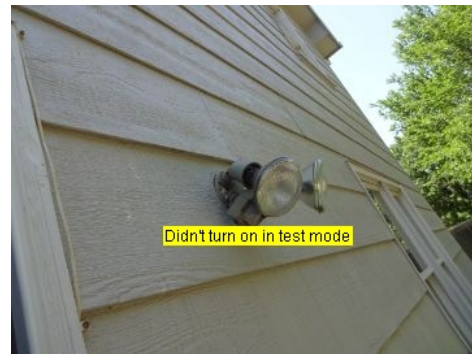
6. Lights & Switches

- A light switch by the front door and one in the living room/dining room didn't seem to operate anything. I recommend asking the seller what they operate.
- The front porch and garage lights turned on for a few seconds and than shut off. I didn't see a photo eye sensor. I recommend verifying with the seller that the lights stay on at night.
- Back porch light didn't turn on when on test mode. I recommend verifying with the seller that it works.

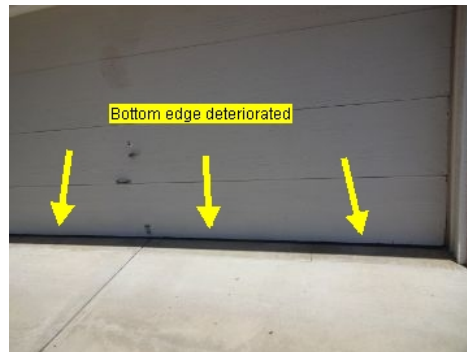
1. Garage Door, Opener, Safety Features

- **Bottom of garage door had some deteriorated areas.**

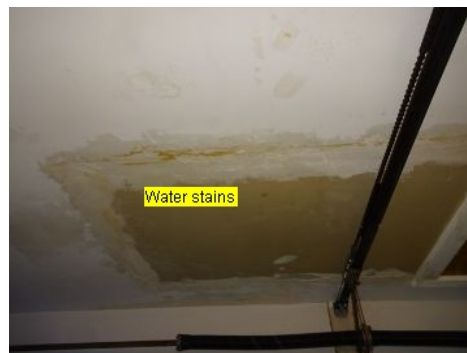
2. Floors, Walls & Ceilings

- **Garage ceiling had some water stains. Without the presence of water from a recent rain, it's not possible to determine if the leaks are active. I recommend verifying with the seller that the cause of the stains have been properly fixed.**

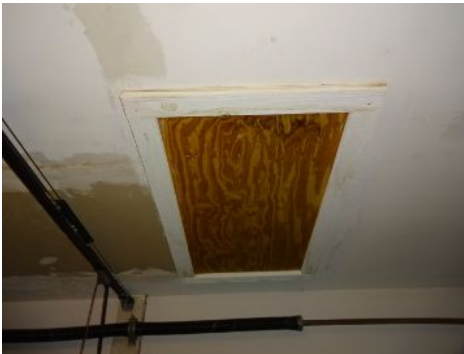
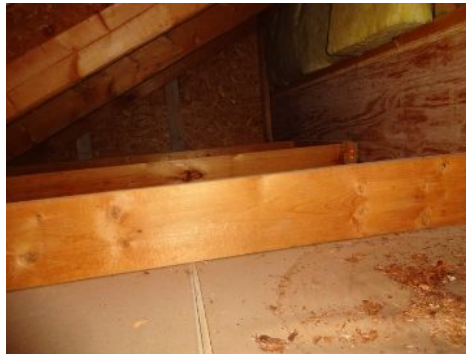
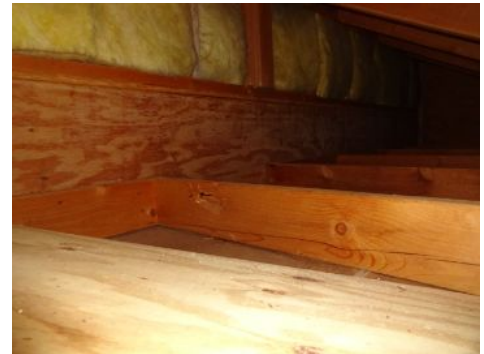
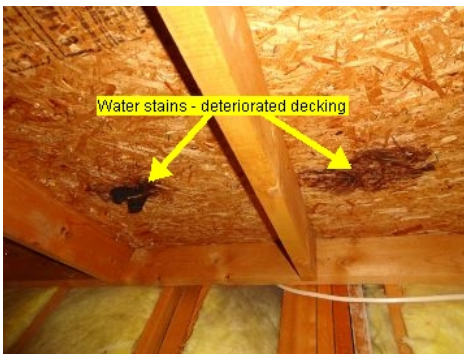
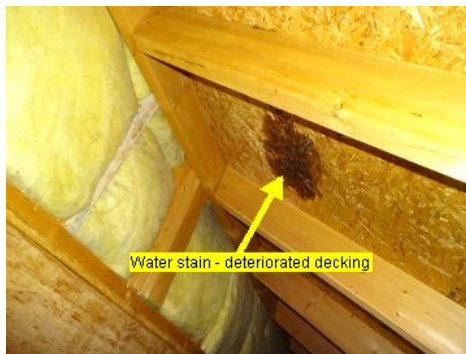
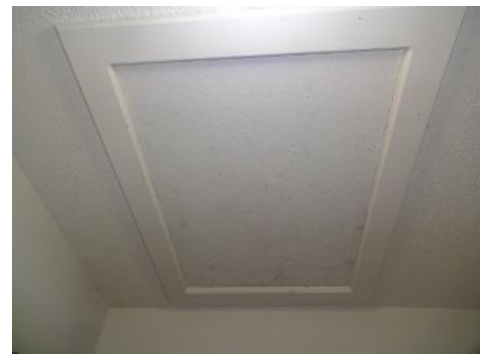
1. Attic Access, Views & Observations

- The attic was accessed by a scuttle hole in the garage and a scuttle hole in the upper level master bedroom closet.
- Attic was inspected from the scuttle hole because there weren't any walking boards visible. Defects may still exist in the areas not visible.
- **Water stains were present on the decking in the attic area above the garage. Without the presence of water from a recent rain, it's not possible to determine if the leaks are active. I recommend verifying with the seller that the cause of the stains have been properly fixed. The roof decking was also deteriorated at the stains.**

Page 19 Item: 1	Attic Access, Views & Observations	<ul style="list-style-type: none">• Water stains were present on the decking in the attic area above the garage. Without the presence of water from a recent rain, it's not possible to determine if the leaks are active. I recommend verifying with the seller that the cause of the stains have been properly fixed. The roof decking was also deteriorated at the stains.
-----------------	------------------------------------	----------------------------------------------------------------------------------------------------------------------------------------------------------------------------------------------------------------------------------------------------------------------------------------------------------------------------------------------------------------------------------------------------
