Insight Inspections, LLC
Home Inspection Report

5534 Prairie Hawk Dr, Bel Aire, KS 67220
Inspection prepared for: Gretchen Stroh
Date of Inspection: 5/21/2018

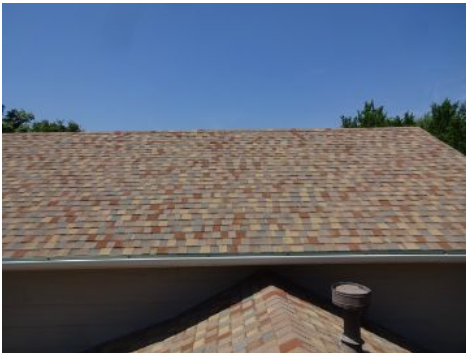
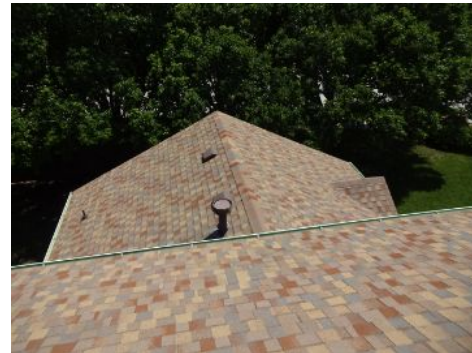
1. Method of Inspection

• NOTE: The pictures demonstrate that the roof and its components were inspected by walking where it could be done safely. Extreme pitch, poor weather conditions, or damage can limit access to some areas of the roof while walking.

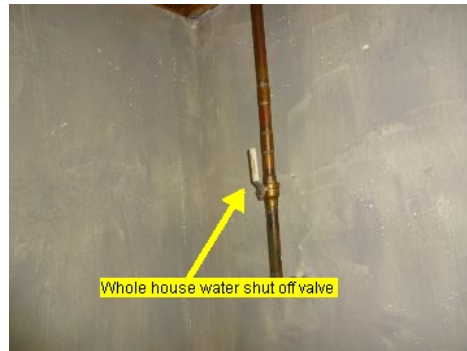
1. Main Shut Off & Water Pressure

- The whole house shut off is located in the lower level mechanical room.
- Water pressure was observed and no deficiencies found.

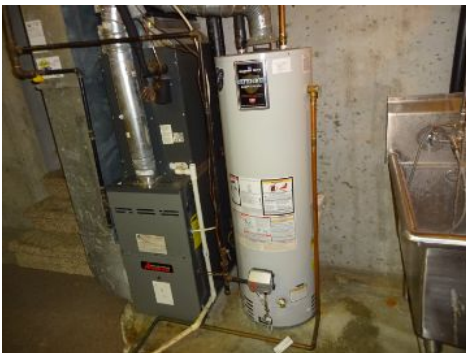
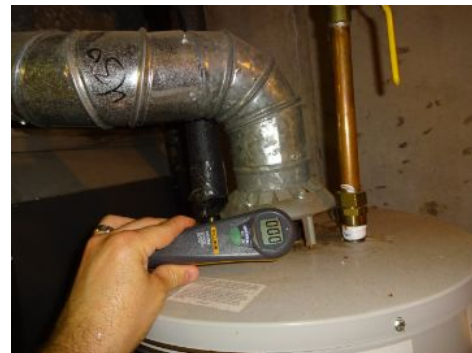
2. Water Heater

- NOTE: You should keep the water temperature set at a minimum of 110 degrees Fahrenheit to kill microbes and maximum of 130 degrees to prevent scalding. Water heaters have a typical life expectancy of 8-12 years.
- Water heater was located in the lower level mechanical room.
- Manufactured in: 2009
- Capacity: 40 Gallons
- No carbon monoxide was detected around the water heater.
- Acceptable

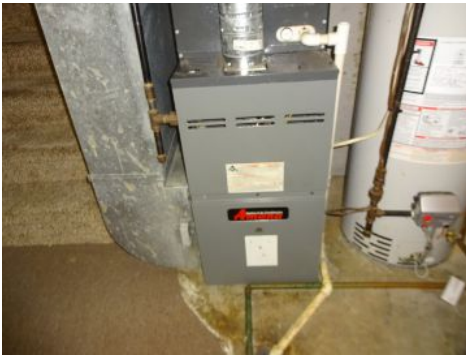
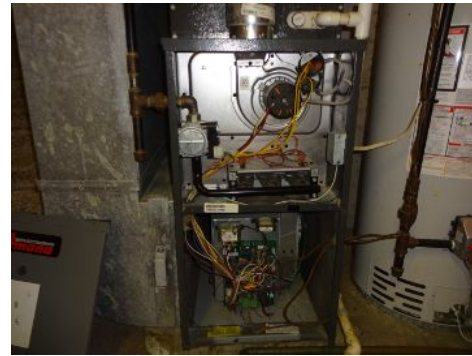
1. Description of Heating System

- The home had a gas central heat furnace that was installed in the lower level mechanical room.
- The furnace was manufactured by Amana in 2010.
- Acceptable

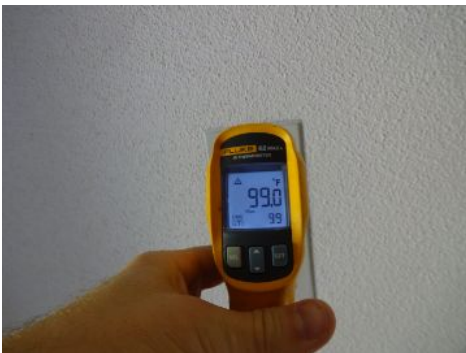
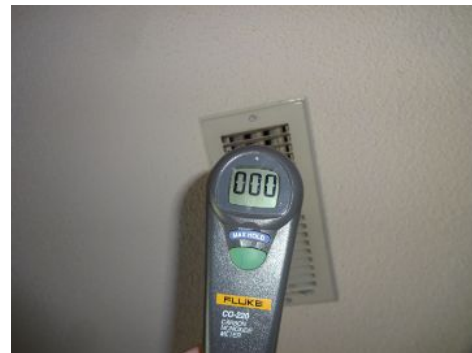
2. Heating Supply

- NOTE: The pictures illustrate that the heating equipment responded to operating controls at the thermostat when placed in the heating mode. Warm air was discharging from the supply air registers. No further equipment diagnostics were performed as part of this home inspection.
- The temperature of the home was tested and no carbon monoxide was detected.

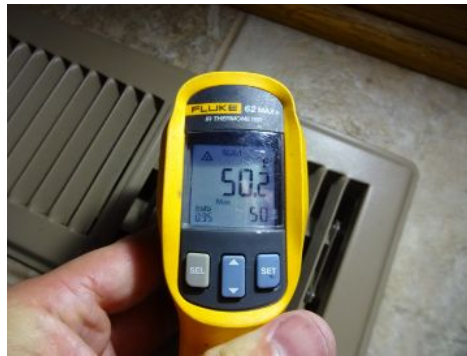
4. Cooling Supply

- NOTE: The pictures illustrate that the cooling equipment responded to operating controls at the thermostat when placed in the cooling mode. Cool air was discharging from the supply air registers. No further equipment diagnostics were performed as part of this home inspection.
- The temperature was tested and no deficiencies were observed.

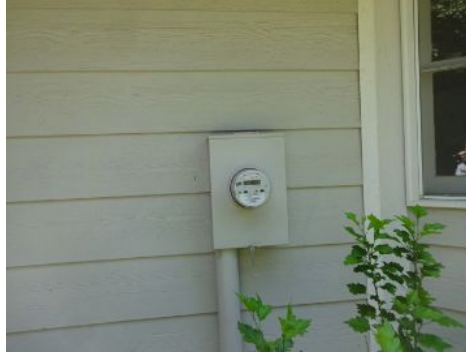
1. Main Electrical Meter & Service

- [Underground Service. Meter located on back side of the home.](#)
- [Acceptable](#)

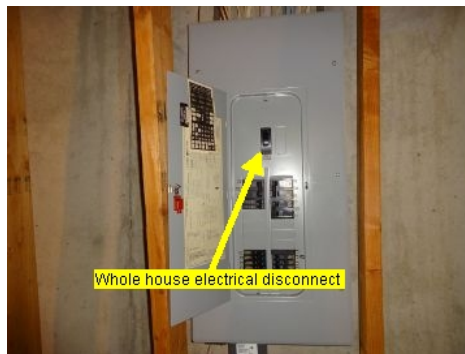
2. Electrical Service Disconnect & Grounding Information

- [Meter was grounded.](#)
- [Service from meter to disconnect was aluminum.](#)
- [Main disconnect was located inside the main panel in the lower level mechanical room.](#)

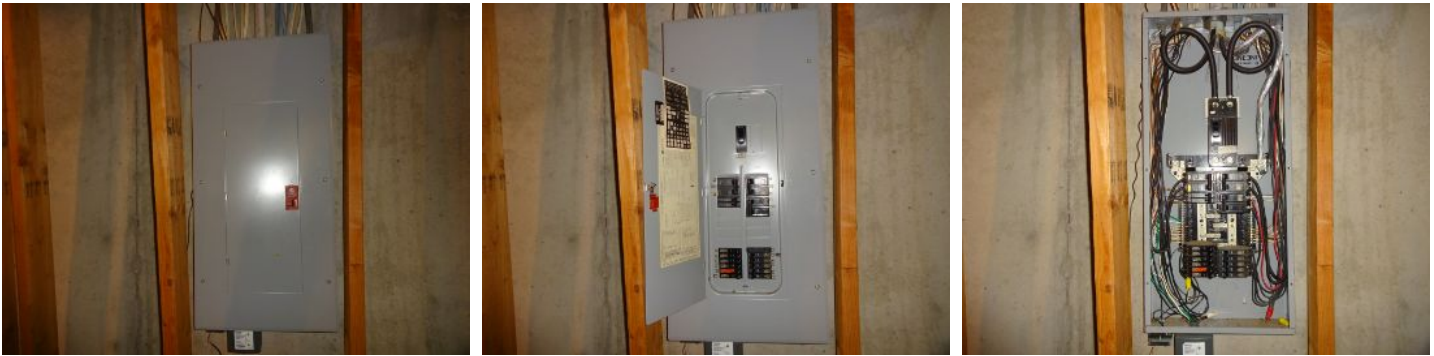
3. Main Service Panel

- [There was a GE main electrical panel located in the lower level that was supplying the home with 200 amps.](#)
- [Acceptable](#)

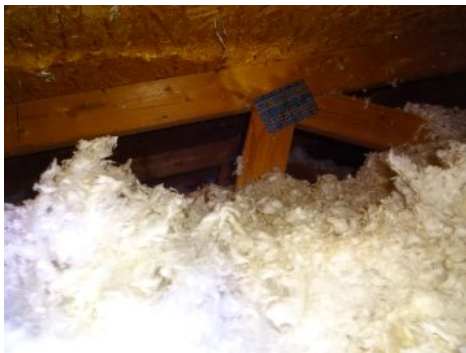
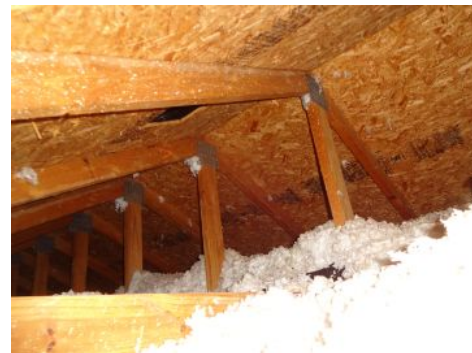
1. Attic Access, Views & Observations

- The attic was accessed by a scuttle hole in the garage and a scuttle hole in the upper level master bedroom closet.
- Attic was inspected from the scuttle hole because there weren't any walking boards visible. Defects may still exist in the areas not visible.
- **Water stains were present on the decking in the attic area above the garage. Without the presence of water from a recent rain, it's not possible to determine if the leaks are active. I recommend verifying with the seller that the cause of the stains have been properly fixed. The roof decking was also deteriorated at the stains.**
